INFORMATION NOTE 25.06.2014

AS PART OF OUR LONG-TERM QUALITY SERVICE, WE DRAW YOUR ATTENTION TO A REGULAR CHECKING OF THE UPPER SEAM ON ALL INTEGRITY HARNESSES.

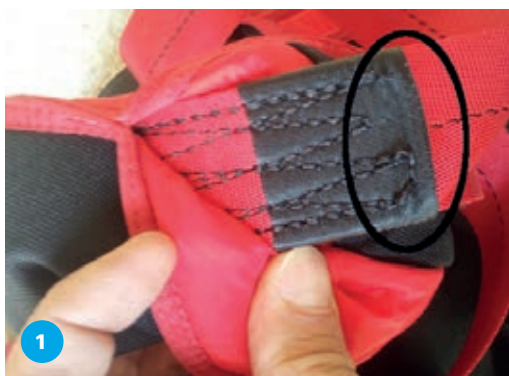
An effect of seams peeling, at the base of the riser, can occur and then this seam is damaged.

This junction is very strong when sewing retains its integrity, but may have low resistance if a tear initiation appears.

On **PICTURE 1**, we can see the beginnings of a tear in the seam on the upper part of the webbing (area circled in black). Straight line perpendicular to the strap, which is set to strengthen the seam and protect its integrity, is absent here. **ON PICTURE 2** seam is present.

- Check regularly the risers seams. This control is very simple and is done visually.

Defects in this seams (rupture of one or more points) must be repaired before the next jump. Do not hesitate to contact us for a verification.
